CONTINUED ON FLINDERS ST (WEST) PASSENGER LINES SIGNALLING DIAGRAM (FAS_0009)

CONTINUED ON SOUTHERN CROSS - NORTH MELBOURNE PASSENGER LINES SIGNALLING DIAGRAM (FAB_0002)

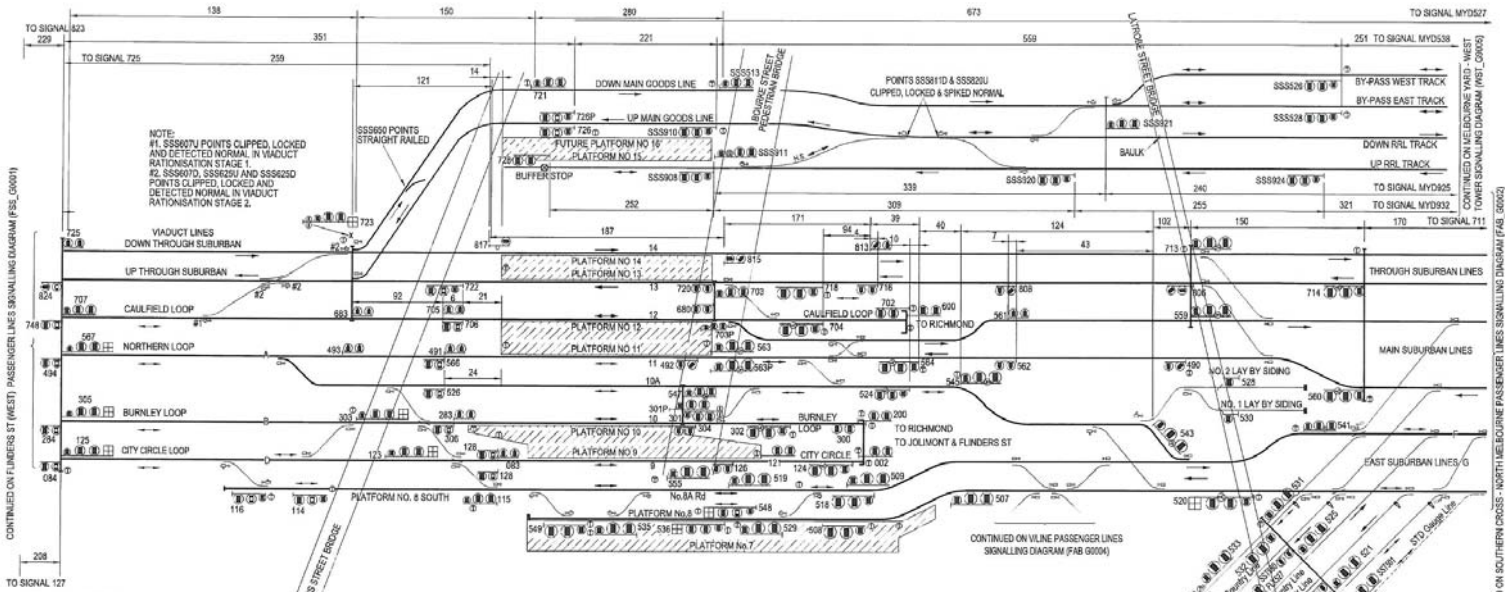
NOTE:
#1. SSS807U POINTS CLIPPED, LOCKED AND DETECTED NORMAL IN VIADUCT RATIONISATION STAGE 1.
#2. SSS807D, SSS820U AND SSS820D POINTS CLIPPED, LOCKED AND DETECTED NORMAL IN VIADUCT RATIONISATION STAGE 2.
